## **Eleventh Month Warranty Maintenance Inspection Report**

### **HAZARDOUS MINE OPENING PROJECT; PHASE 25, PROJECT 28**

**DSL-AMRB 90-022**

**September 1992**

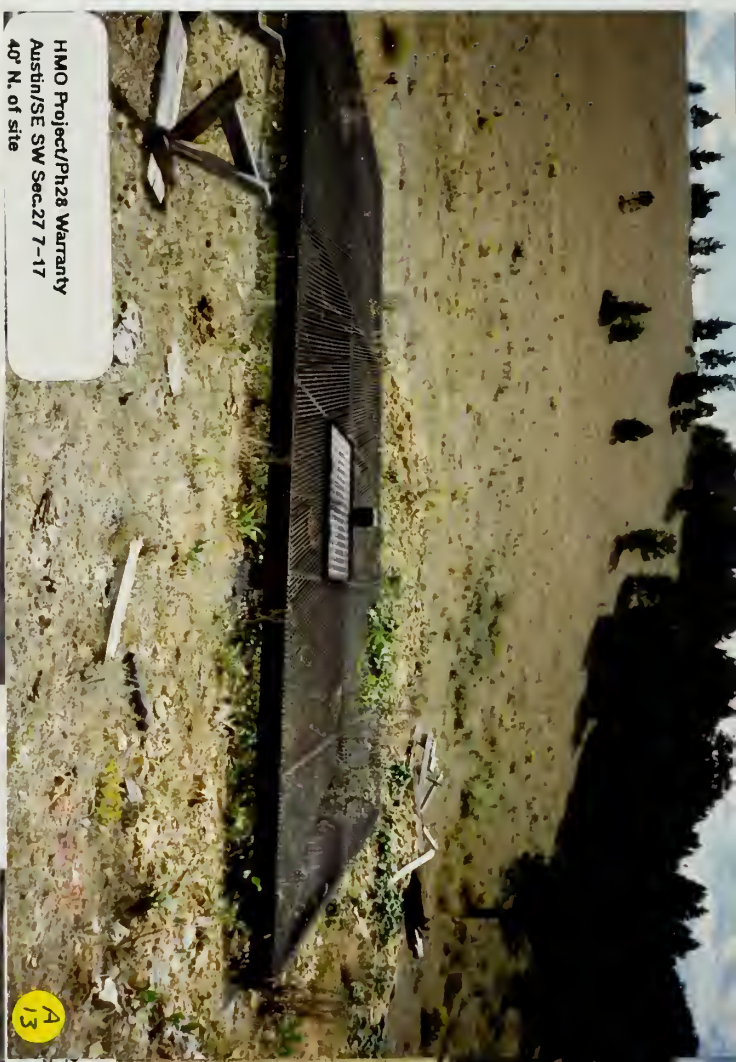
HMO Project/Ph28 Warranty  
Austin/SE SW Sec.27 7-17  
40' N. of site

PA #	DISTRICT	SITE	NO.	RESPONSIBLE PARTY	CONDITION DESCRIPTION & RECOMMENDATIONS
25-219	Austin	SE SW Sec. 27	7-17	AMRB	Noxious weeds.
25-060	Marysville	Allegheny	2-2	--	Need hazard signs installed.
25-076	Marysville	Drumlummon	10-19	AMRB	Noxious weeds.
25-077	Marysville	Earthquake	40-36	--	Minor subsidence. Monitor site for further settlement.
25-015	Marysville	Empire	12-43	Landowner	Mine timbers have been vandalized and access gained around adit gate.
25-182	Marysville	Larson	19-50	--	Bullet holes in hazard sign.
25-080	Marysville	North Star	3-21	AMRB	Noxious weeds.
25-170	Marysville	NW NE Sec. 27	22-53	Landowner	Portal timbers have been vandalized and access gained from above and behind adit gate.
25-135	Marysville	Robert Emmet	25-63	--	Need hazard signs installed.
25-181	Marysville	Strawberry	17-93	--	Minor subsidence. Monitor site for further settlement.

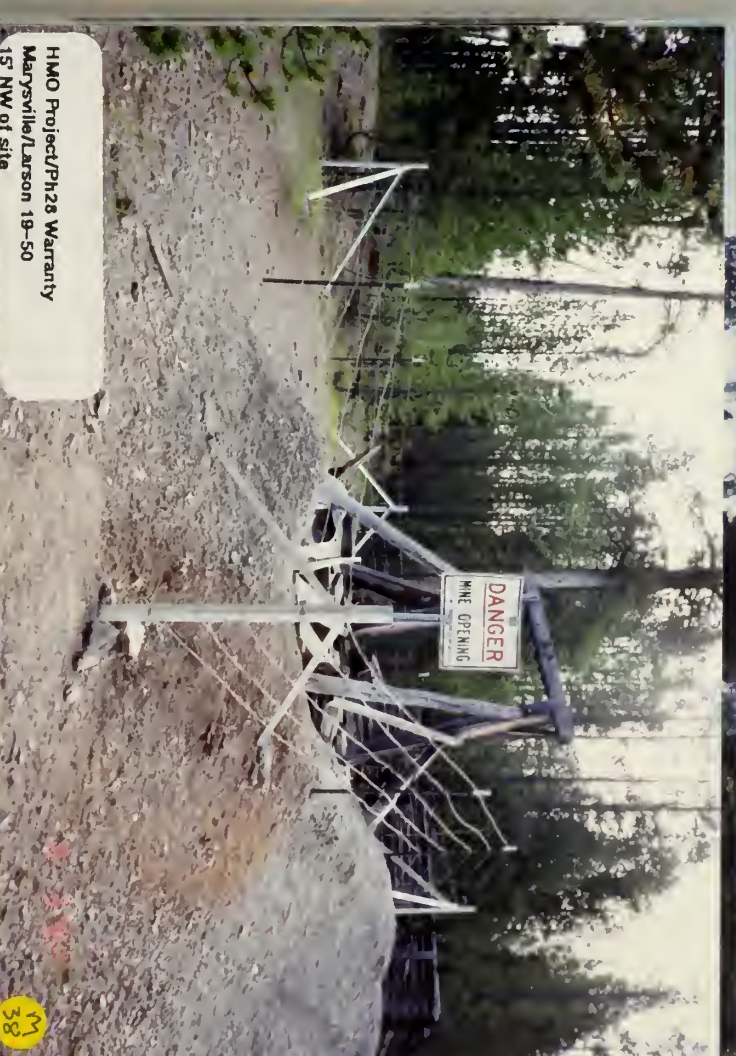
HMO Project/Ph28 Warranty  
Marysville/Larson 19-50  
15' NW of site

Two incidents of vandalism occurred in the Marysville District. At the Empire site # 12-43 mine timbers and shoring have been removed and access gained around the adit gate. The NW NE Section 27 site # 22-53 adit has been accessed by removing earth and timbers from above and behind the steel gate. In addition, one "Hazard" sign at the Larson site # 19-50 was observed to contain bullet holes.

25-182	Larson	19-50	Fence	Good	M-38	Bullet holes in hazard sign.
25-315	Last Hope	41-51	3' Culvert	Good	M-39	Good vegetation.
25-177	Little Giant	21-52	Fence	Good	M-40	
25-170	NW NE Sec. 27	22-53	Adit Gate	Vandalized	M-41	Mine timbers have been removed and access gained from above and behind adit door.
		22-56	3' Culvert	Good	M-42	Fair vegetation with some weeds.
25-312	NW NW Sec. 11	44-58	Fence	Good	M-43

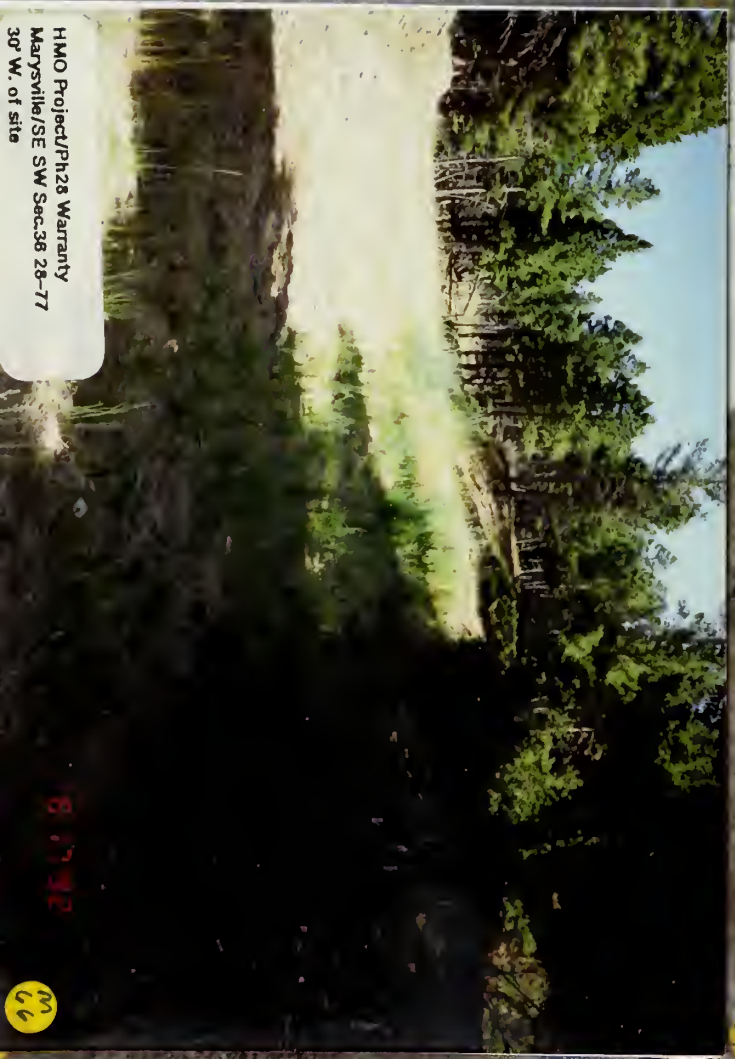
HMO Project/Ph28 Warranty  
Marysville/SE SW Sec. 36 28-77  
30' W. of site

PA #	SITE NAME	NO.	CLOSURE	CONDITION	PHOTO NO.	COMMENTS
25-133	SE SW Sec. 36	28-77	Backfill	Good	M-66	Excellent vegetation.
		28-78	Backfill	Good	M-67	Excellent vegetation.
25-086	Shannon	30-96	Backfill	Good	M-68	Excellent vegetation.
25-119	SW NE Sec. 31	29-79	Fence	Good	M-69	
25-313	SW SW Sec. 10	46-80	Fence	Good	M-70	
25-114	SW SW Sec. 30	43-81	Cable Net	Good	M-71	
25-128	Snow Bird	34-83	24' x 32' Grate	Good	M-72	Excellent vegetation.
25-181	Strawberry	17-92	Backfill	Good	M-73	Excellent vegetation.
		17-93	Blast	Minor Sub.	M-74	Excellent vegetation. Monitor subsidence.
		17-94	Backfill	Good	M-75	Excellent vegetation.
		17-95	Backfill	Good	M-76	Excellent vegetation.
		17-99	Backfill	Good	M-77	Excellent vegetation.
25-166	Tyson	36-85	Fence	Good	M-78	
25-082	Vestal	37-86	Fence	Good	M-73	
25-174	Whippervill	38-87 38-88	Fence	Good	M-80	
25-340	Z-G # 18	46-89	Fence	Good	M-81	
		48-90	Culvert	Good	M-82	Fair vegetation.
